**SUBJECT:** A machine operator died when crushed in a plastic injection molding machine.

**SUMMARY**  
**California FACE Report #03CA006**

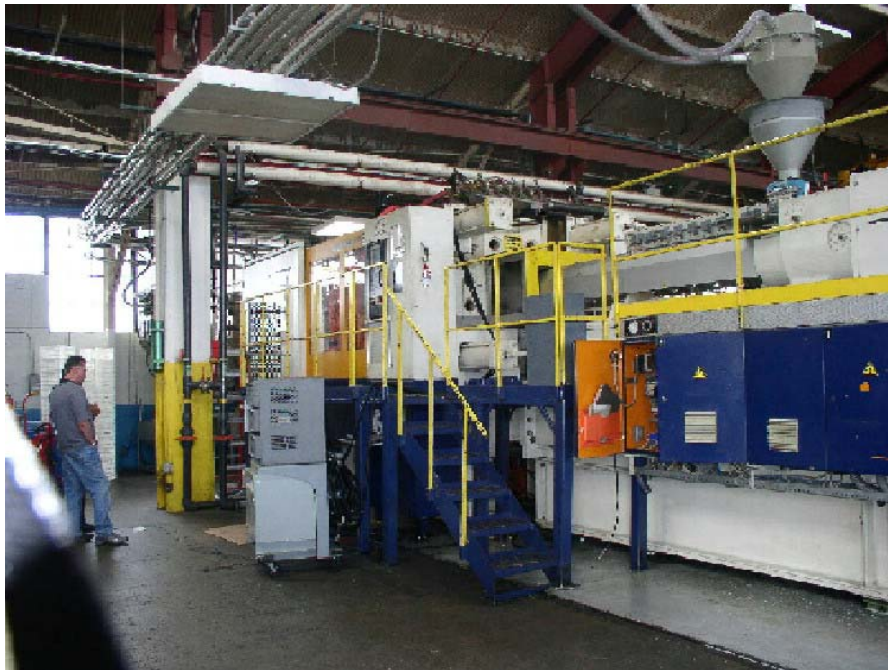
Exhibit #1

View of the front side of the plastic injector mold involved in this incident.

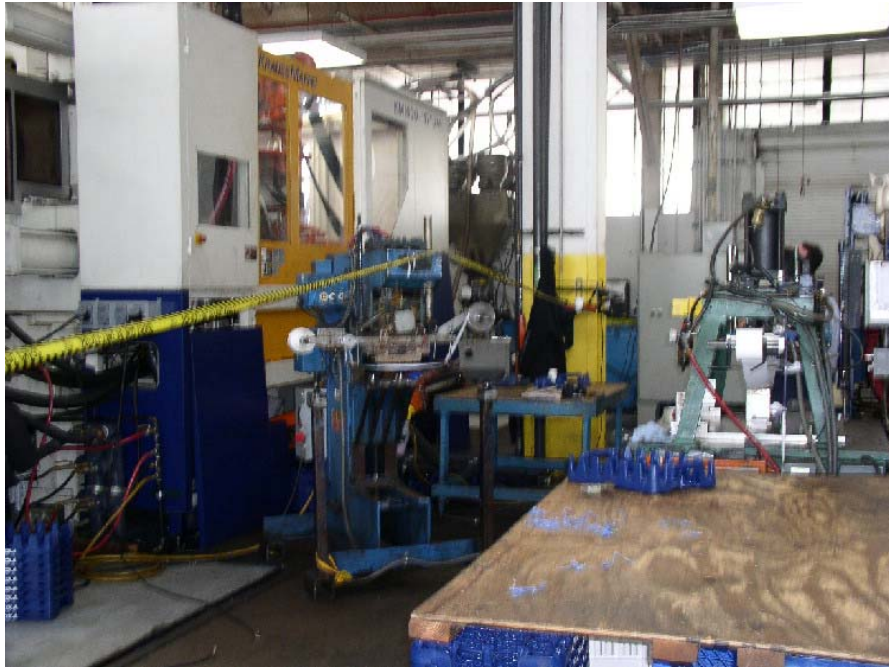
03CA006  
Exhibit #2

View of the back side of the plastic injector mold involved in this incident.

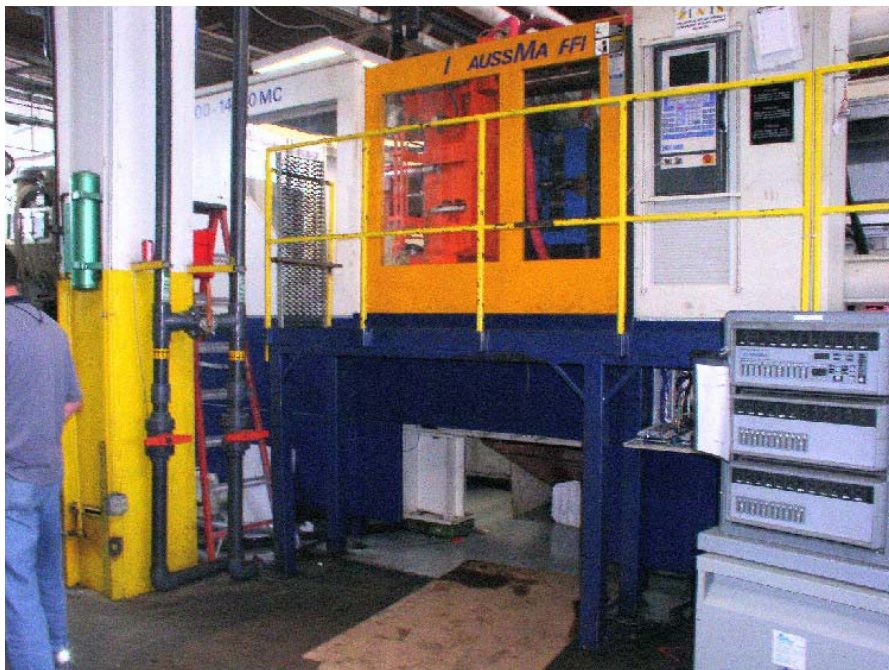
03CA006  
Exhibit #3

Investigation of the incident site revealed the victim's tools lying next to the opening in the pedestal where the conveyor belt was located, and several pieces of the machine product laying scattered about the conveyor belt. The guard or shield on the side of the conveyor belt was unbolted on one side. These factors suggest that the victim crawled into the machine from the opening of the conveyor belt not being used. Once inside, he may have attempted to adjust the shield or guard to prevent the product from bouncing off the conveyor belt. Because the area he was in was extremely restrictive (approximately 51" long, 48" wide, and 58" high), he may have tried to stand up when the machine cycled, not realizing that the mobile portion of the mold would cycle backward again. When the machine cycled back, the victim may have been unable to move out of the way and his head got caught between the frame of the pedestal and the frame of the mold.

View of the location where the victim entered inside the injector mold.

Discussion: The purpose behind a lockout/tagout procedure is to ensure the release of any stored energy within a machine, then lock that source out while the machine is being worked on to protect the worker. In this case, the victim was trained and authorized to activate the lockout/tagout procedure. Had the victim implemented the lockout/tagout procedure, this incident might have been prevented.

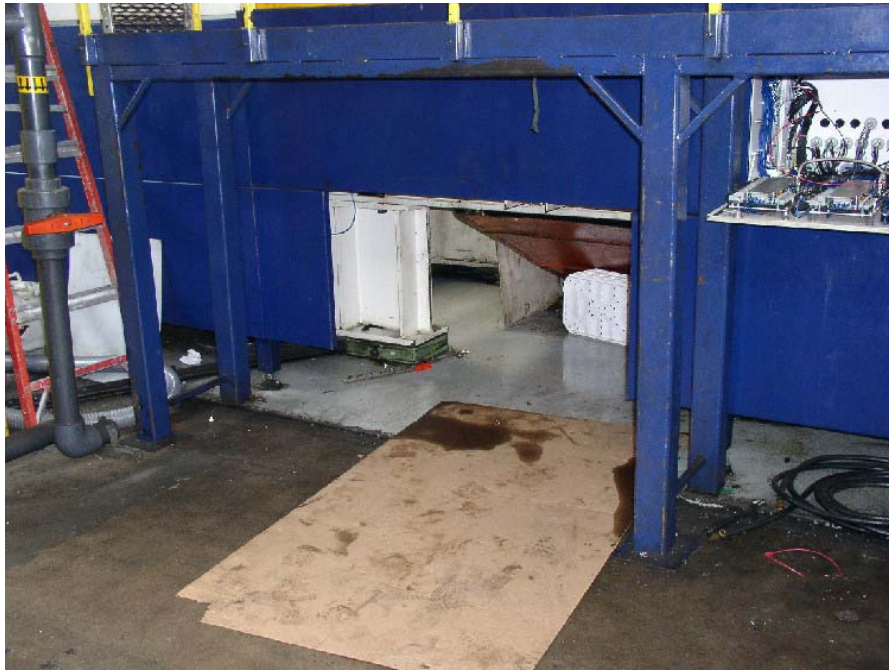
Exhibit #4

View of the area where the victim removed the conveyor belt to gain access to inside the injector mold.

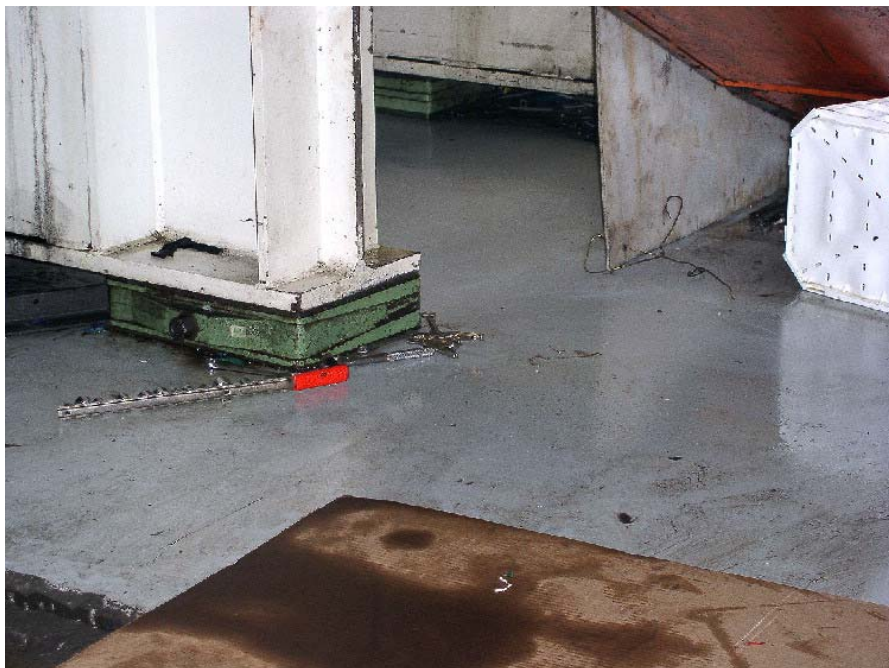
Exhibit #5

This is a picture of the victim's tools at the point of entry.

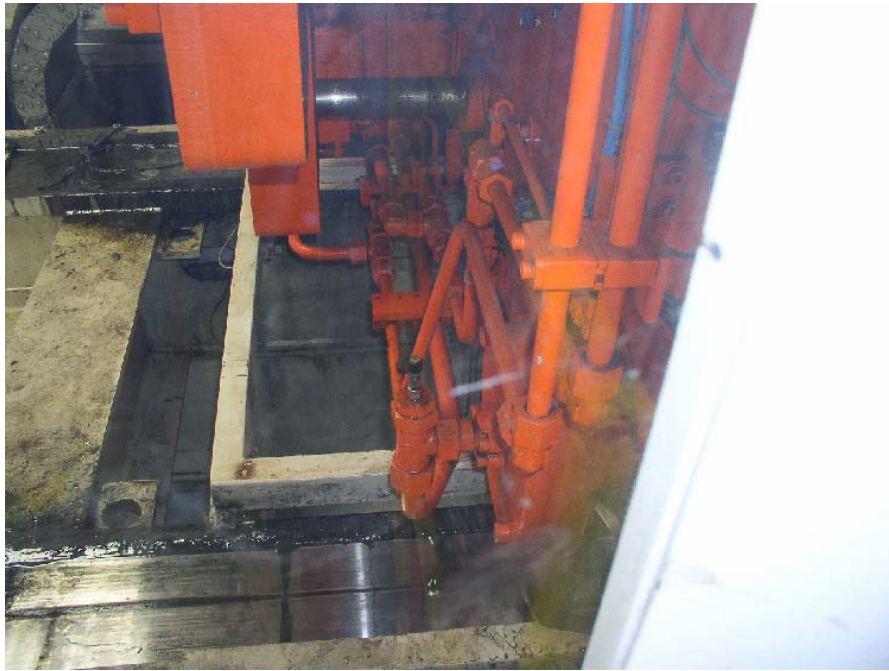
Exhibit #6

View of the area where the victim was caught looking from the top down.

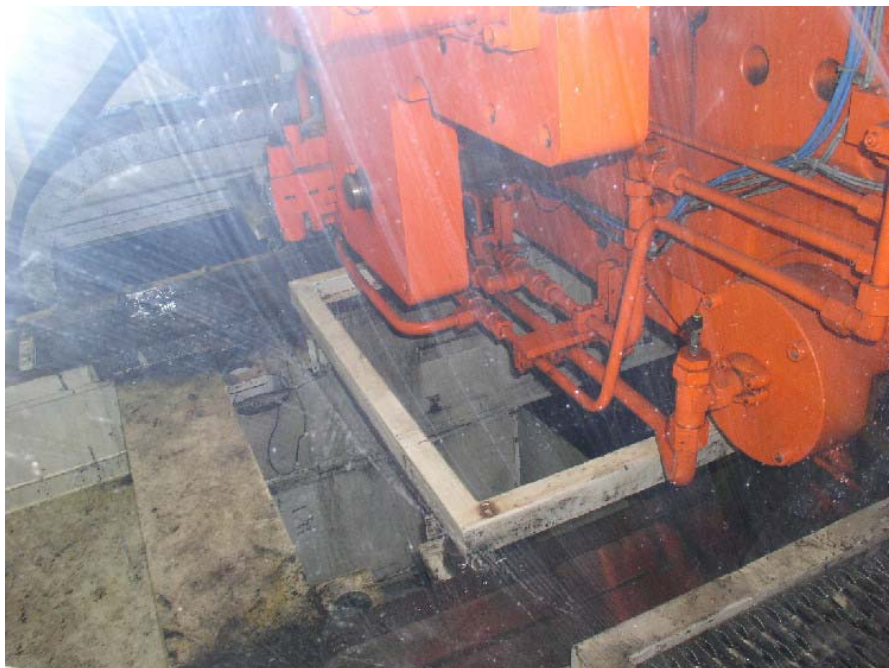
Exhibit #7

Another view of the area where the victim was caught looking from the top.

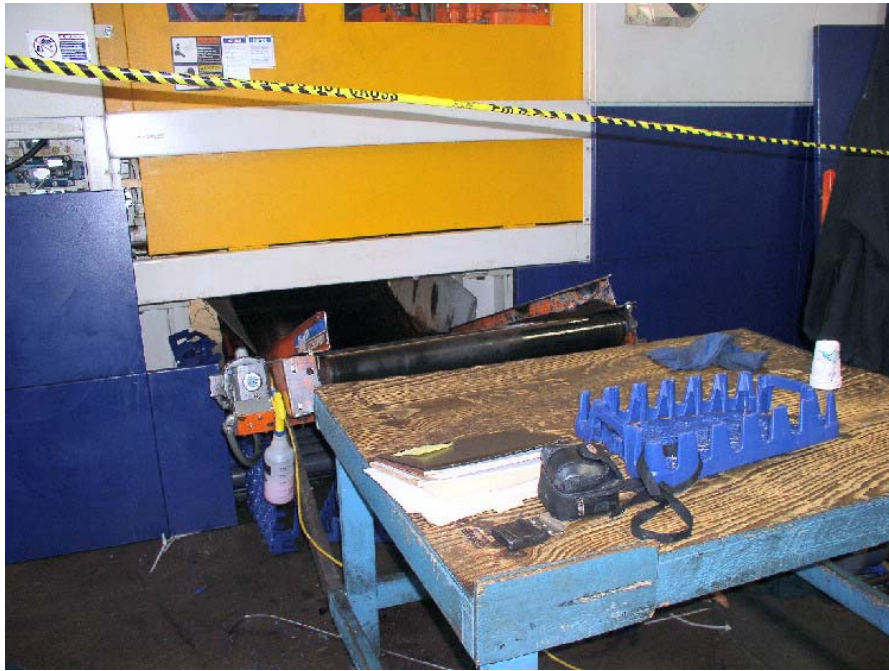
Exhibit #8

View of the victim's work area on the back side of the injector mold.

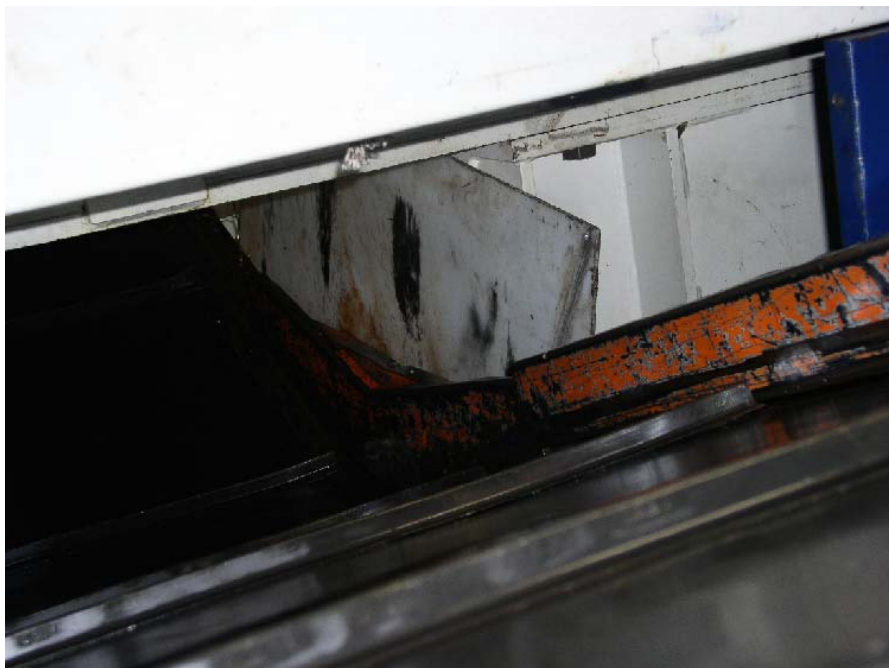
Exhibit #9

View of the conveyor belt used to catch and transport freshly molded products.

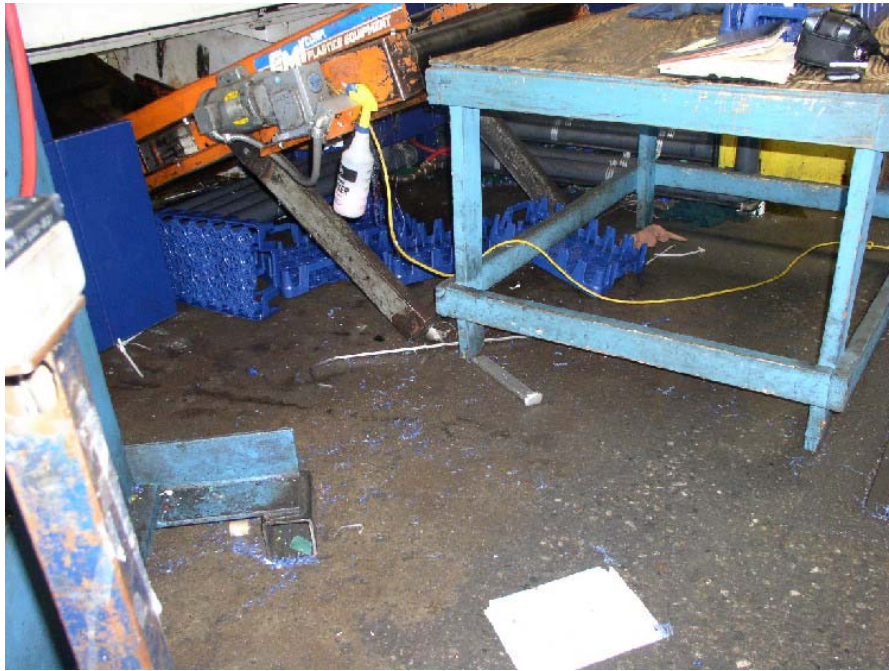
Exhibit #10

View of the victim's work station with freshly molded products on floor.

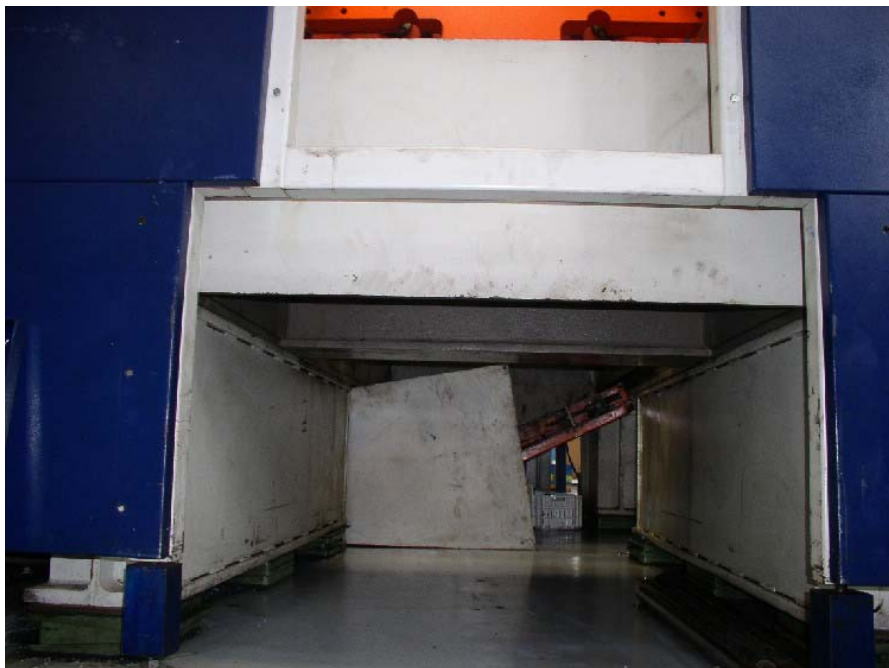
Exhibit #11

View of the left side of the injector mold with a panel removed to show where the victim was caught.
